If the machine is not executing the last bend in a series, it is usually due to the last bend falls in a position that is beneath the programmed limit switch settings according to the toolset.

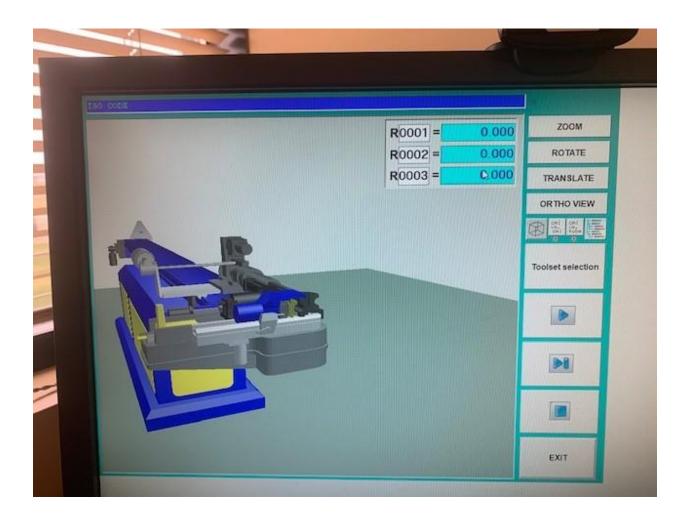
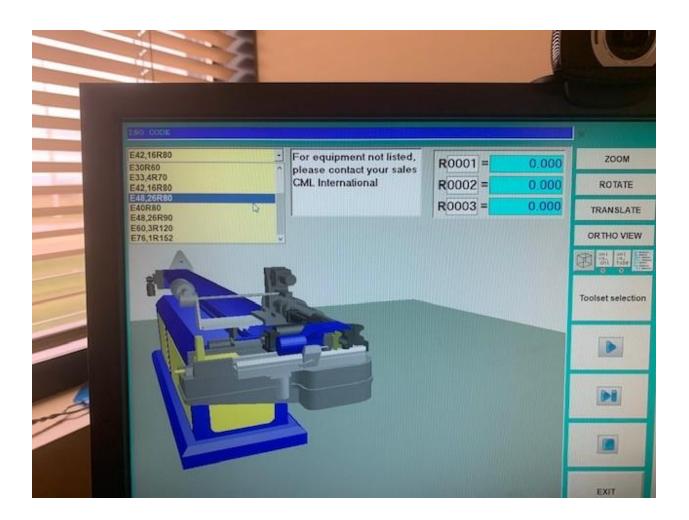
The Y Axis Bend die Interference and Y axis Pressure die interference define the zone for the Y axis to position.

If the programmed bend position lies underneath (smaller value) then machine will not execute that bend and will show a fault or alarm noting the position is under the limit switch value.

A quick way to see if any bends are programmed under the limit switch is to look at the YBC page of the program and compare these values to the setting on the respective toolset.

The columns labeled BEGIN and END show where each respective bend lies along the overall developed length.

The solution in this case is to add material to the overall length if possible and move the bend location out of the interference zone or to change the settings on the toolset file IF there is NO mechanical interference with the wiper die bracket or the pressure die bracket. If the machine is showing alarms or collision during the simulation, check to see if the correct simulation toolset is selected for the animation. The simulation graphics are NOT automatically set according to the current polar file. You must select the toolset on the simulation page. Choose a toolset that closely matches the radius of your actual tooling .

If you are seeing, collision with clamp also be sure that the programmed distance between your bends is NOT shorter than the clamping distance on the former and clamp die.
